Environmental Assessment Determinations and Compliance Findings for HUD-assisted Projects 24 CFR Part 58

West Point Apartments

September 2016

10 E. Broadway Boulevard, Tucson Pima County Arizona 85701. Pima County Assessor parcel numbers: 117-13-0390.

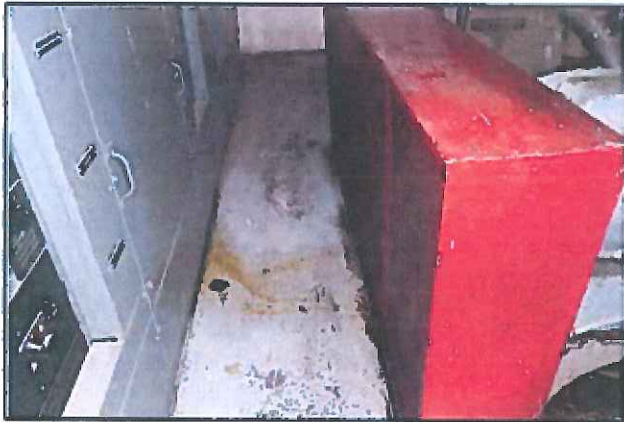
On October 1, 2015 a Phase I was conducted at the Property (WT Job Number 2985JC106). The ESA revealed the leaking transformer fluid in the basement to be a REC and recommended the fluid be assessed for the presence of PCBs.

Picture 1 – Wall mounted transformers and unknown fluid leaking on the concrete slab, October 1, 2015.

On September 2, 2016, Mr. Jason Criss and Ms. Vanessa Lentini with WT visited the Property to collect the spilled fluid in the basement mechanical room. Upon arrival, WT noted the fluid to be gone and the foundation was dry with de minimis staining (see attached images). WT was unable to collect a sample of the suspect spilt fluid and therefore did not submit any samples for laboratory analysis.

WT has no further recommendations for the leaking transformers in the basement and no longer considers this a REC to the Property.

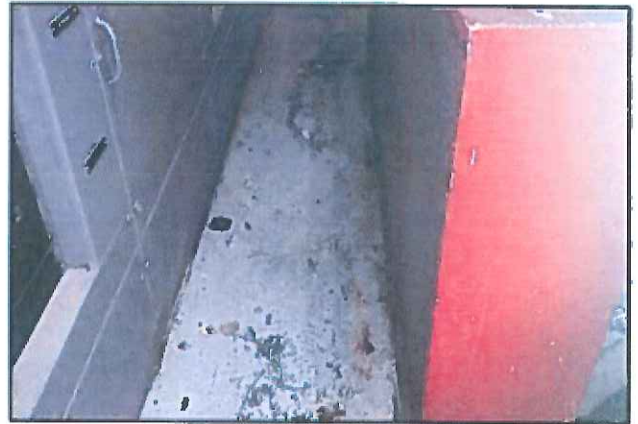
Picture 2 – No visible fluid on the concrete September 2, 2016.

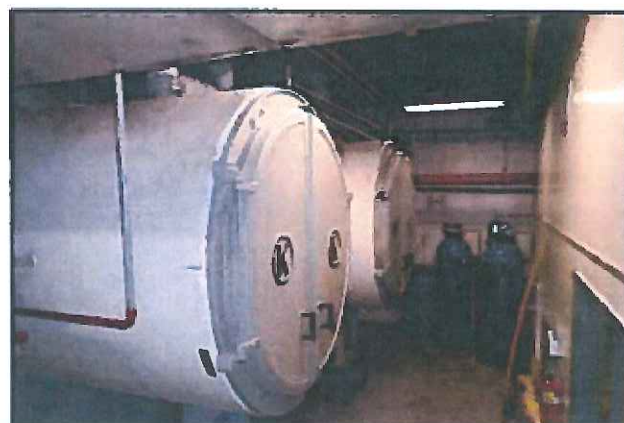
Picture 6 – View of two boilers, in the mechanical room of the structure.

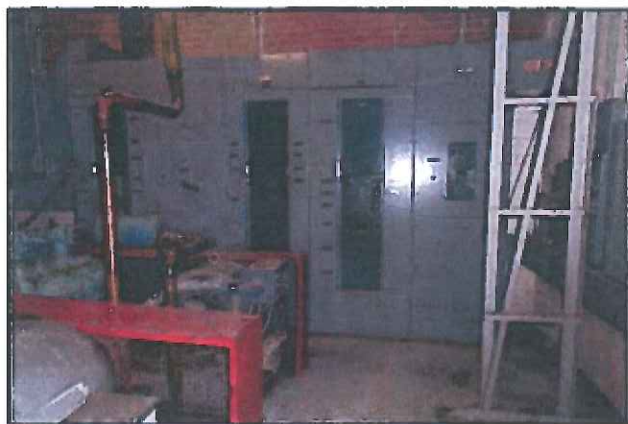
A panel of four, wall-mounted transformers on the east wall in the mechanical room provided electricity to structure. At the time of the reconnaissance, the transformers were damaged and leaking an unknown fluid onto the concrete floor. The leaking fluid had stained portions of the concrete, and pooled fluid remained in low-lying areas. Based on the damaged and leaking condition of the transformers, WT considers this a REC to the Property.

Picture 7 – View of electrical wall panels in the mechanical room.

- **Leaking Transformers** - WT recommends the leaking transformer fluid be assessed for the presence of PCBs and managed accordingly.
- **Emergency Generator** – WT recommends the diesel fuel and all other containers be properly removed.

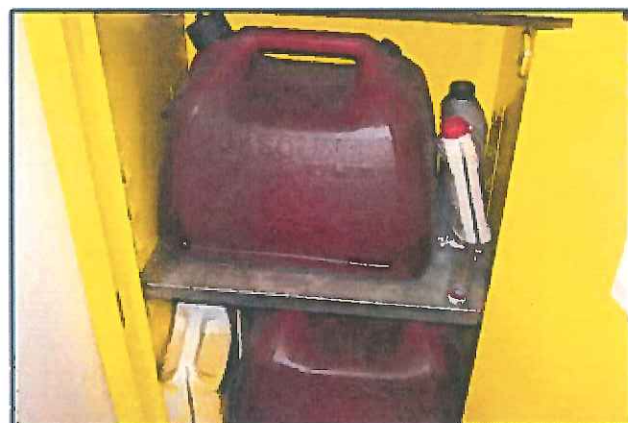
- **Emergency Generator** - A flammable storage cabinet and various 5-gallon containers of paint, and roofing materials, along with 5-gallon metal containers of fluids and lubricants were stockpiled on the roof, west of the emergency generator. Based on the current condition and storage of diesel fuel, fluids and lubricants containers, WT considered this as a potential REC to the Property.

Picture 11 – View of plastic gasoline containers full of diesel fuel.

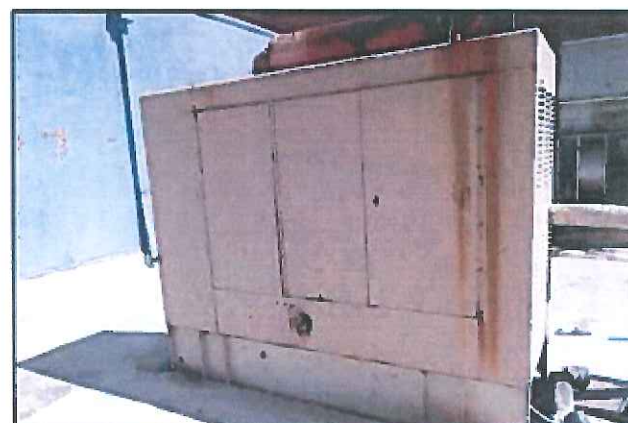
A back-up diesel power generator was on the roof of the structure. WT estimated that the fuel tank could hold approximately 10-15 gallons of diesel fuel, but was unable to determine to exact amount. WT did not observe staining or leaking from the generator, therefore the generator was not a REC to the Property.

Picture 12 – Emergency generator on the roof.

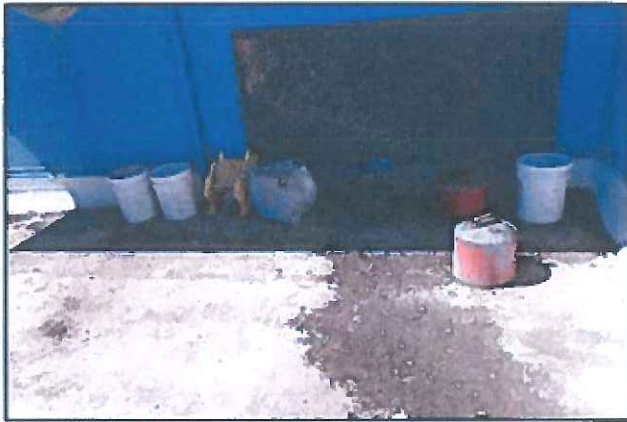
Picture 13 – Plastic and metal containers.

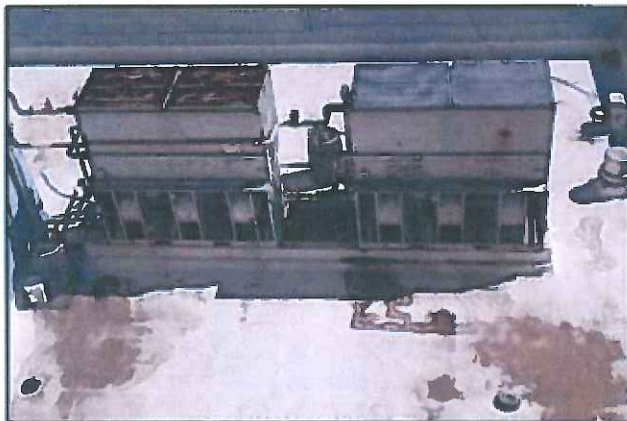
Picture 15 – View of roof mounted cooling towers.

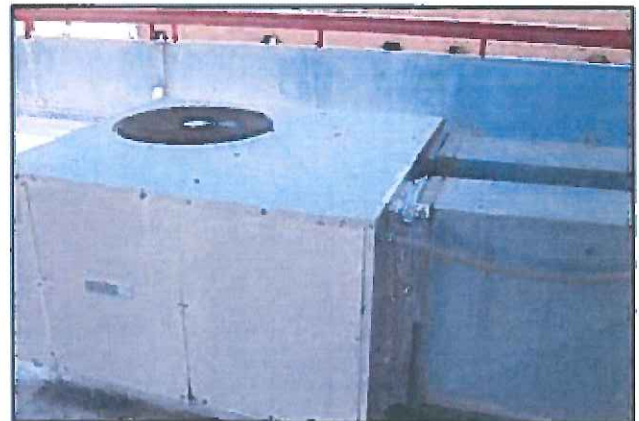
Picture 16 – View of roof mounted air handler units.

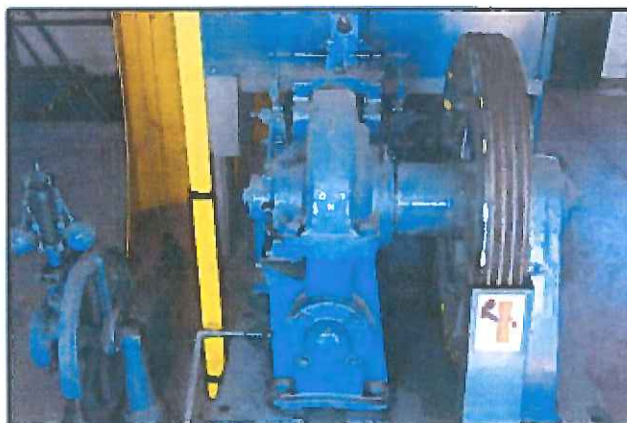
The commercial structure contained three cable guided elevators, each with operating equipment that consisted of a drive shaft, hydraulic oil reservoir, pumps and counter weight systems. The elevators were taken out of service by the City of Tucson in June 2011. WT observed maintenance and service records for the elevator that dated back to the late 1960's. We observed some oily staining and ponding liquid on the concrete around the base of the elevator. Based on our observations, we believe the staining was de minimis in nature and does not represent a REC.

Picture 17 – View to cable elevator system, including cables and associated equipment.

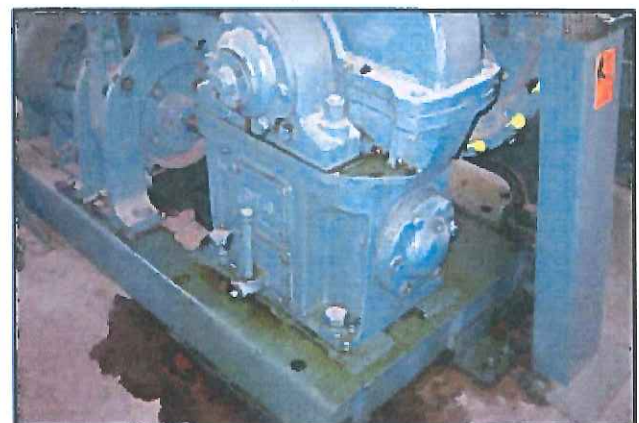
- **Elevator Equipment** - The commercial structure contained three cable guided elevators, each with operating equipment that consisted of a drive shaft, hydraulic oil reservoir, pumps and counter weight systems. WT observed some oily staining and ponding liquid on the concrete around the base of the elevator. Based on our observations, we believe the staining was de minimis in nature and did not represent a REC.

Picture 18 – View of leaking fluid from the elevator equipment.

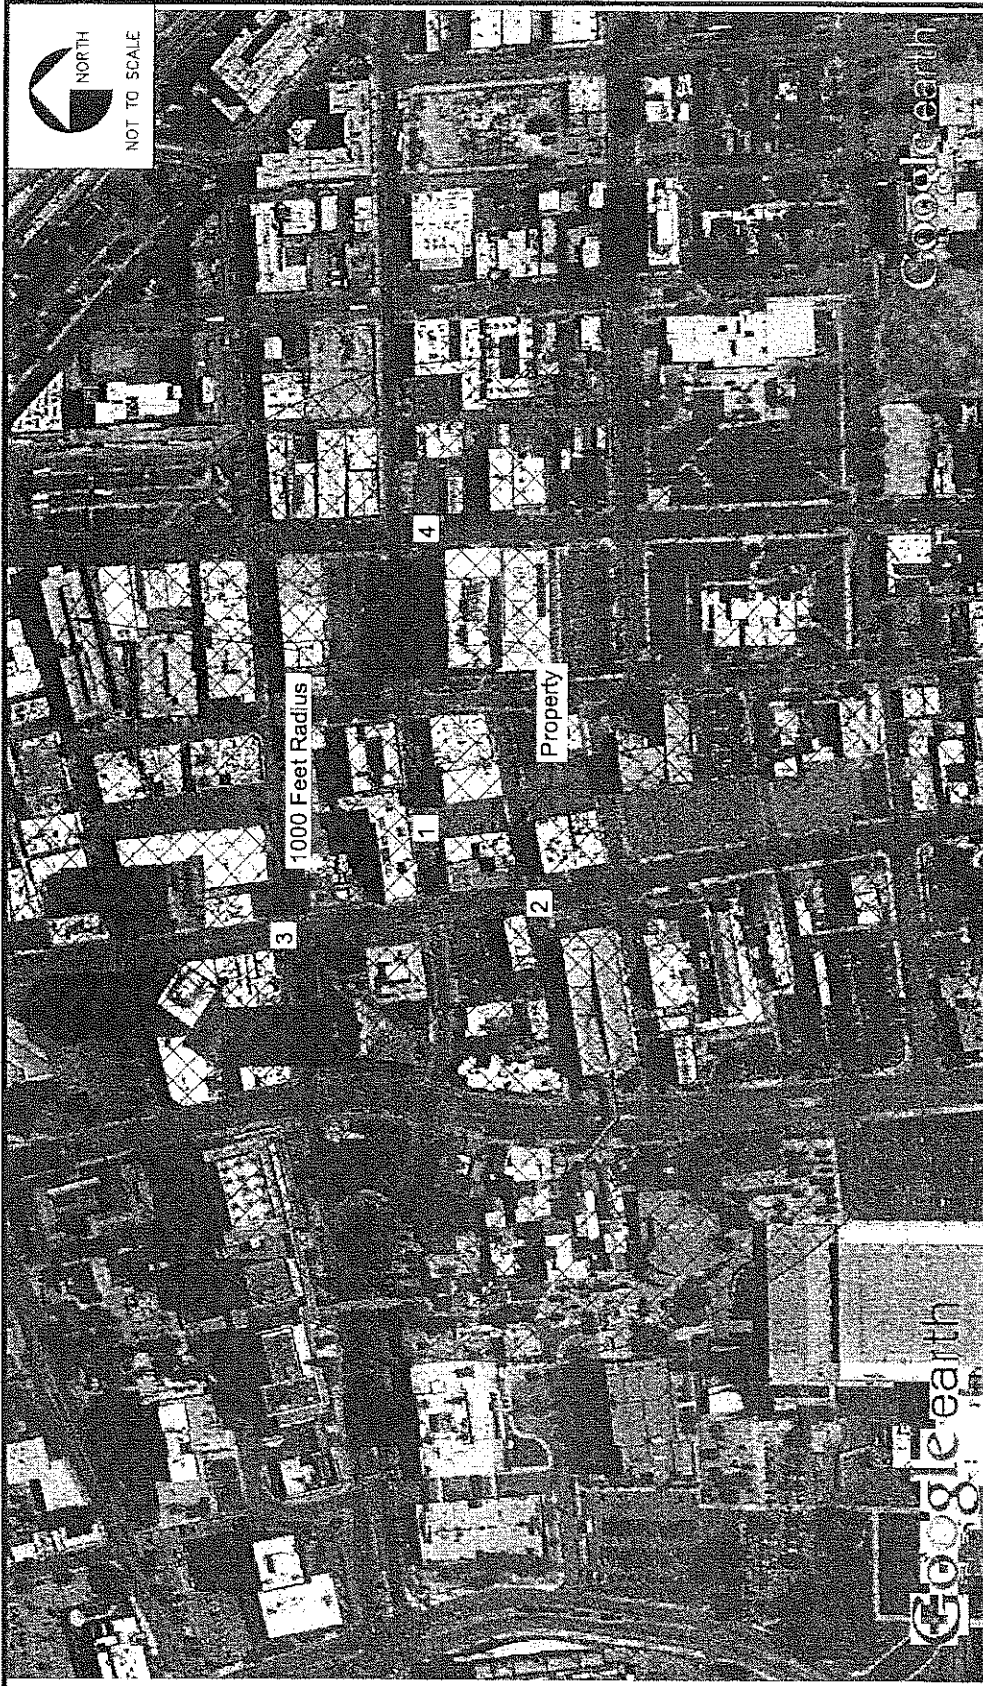
1. E Broadway Blvd
2. S Stone Ave
3. E Congress St.
4. S 6th Ave

FIGURE 4. ROADWAY NOISE EVALUATION
HUD NOISE ASSESSMENT
The Westerner
10 East Broadway Boulevard
Tucson, Arizona
